# Concrete Shower Pan Cracking

**Dirk Duffner**  
**Duffner Engineering**  
**[dduffner@duffnerengineering.com](mailto:dduffner@duffnerengineering.com)**

# Summary

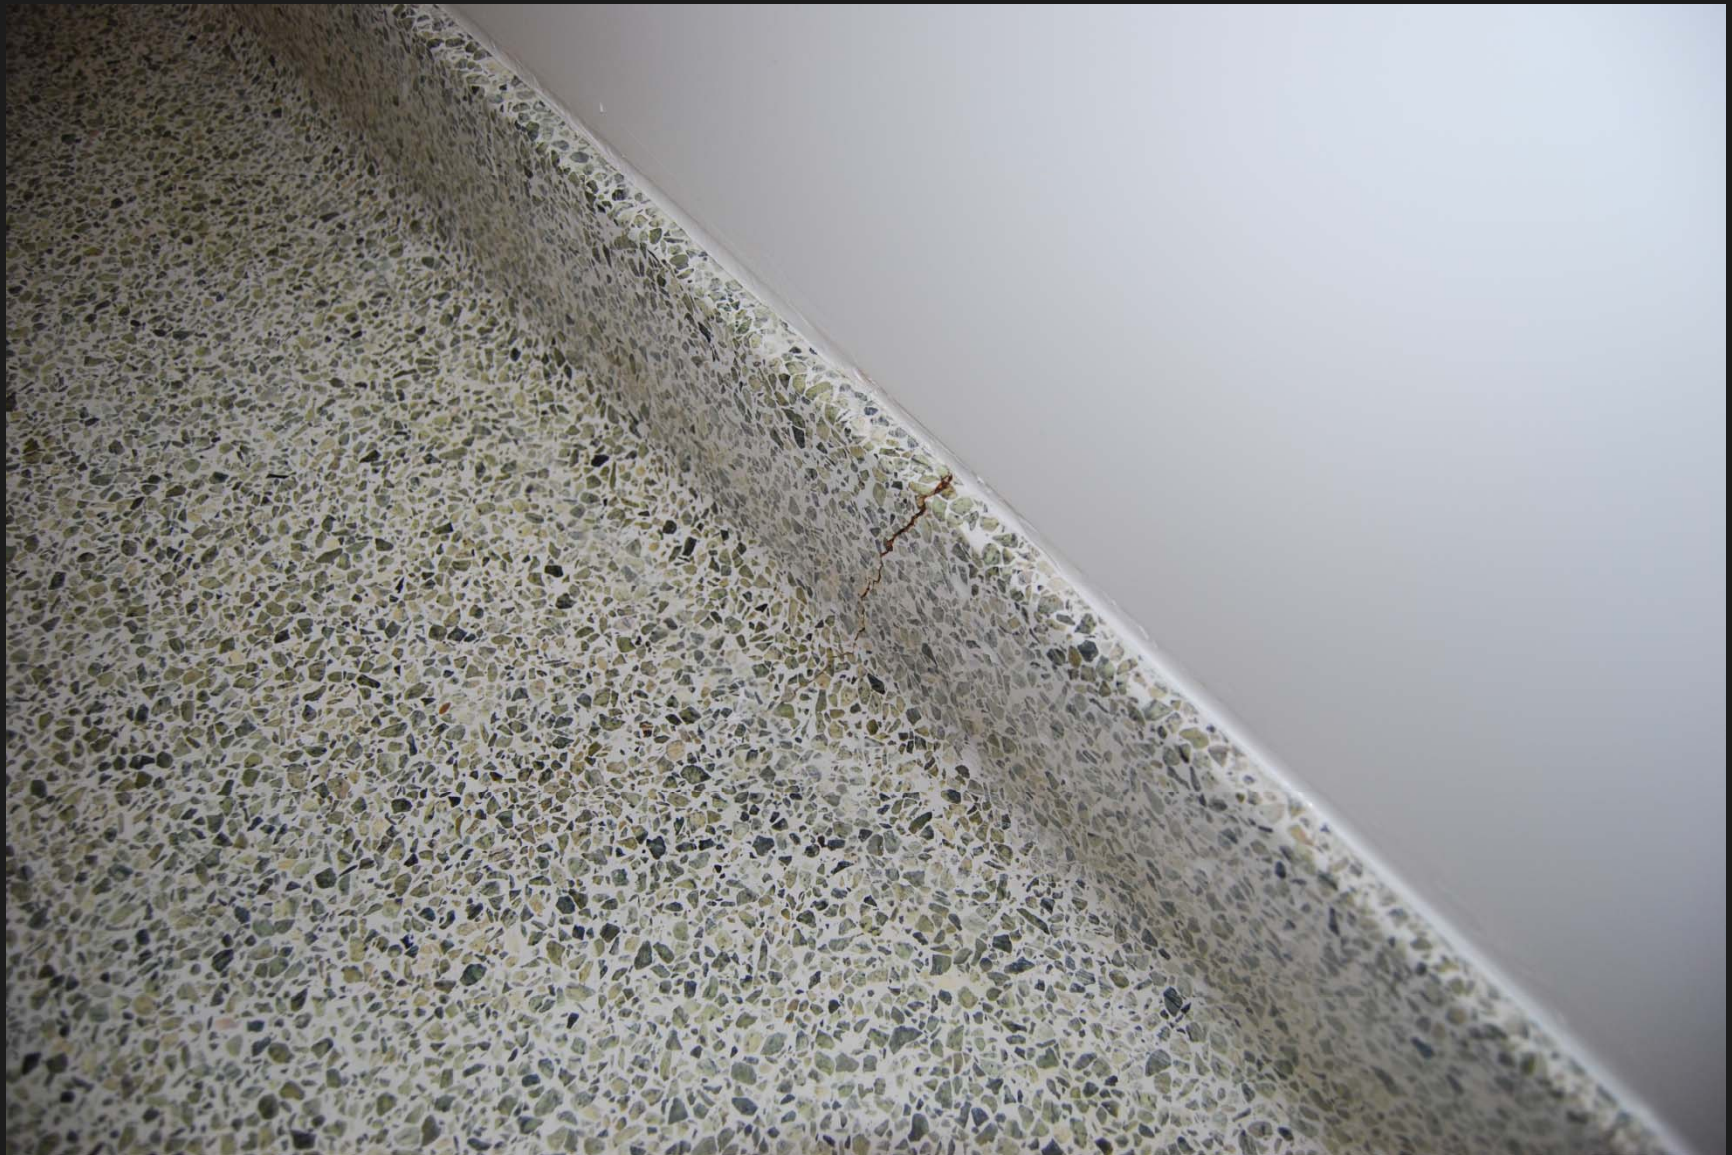
# Crack Discovered in the Curb

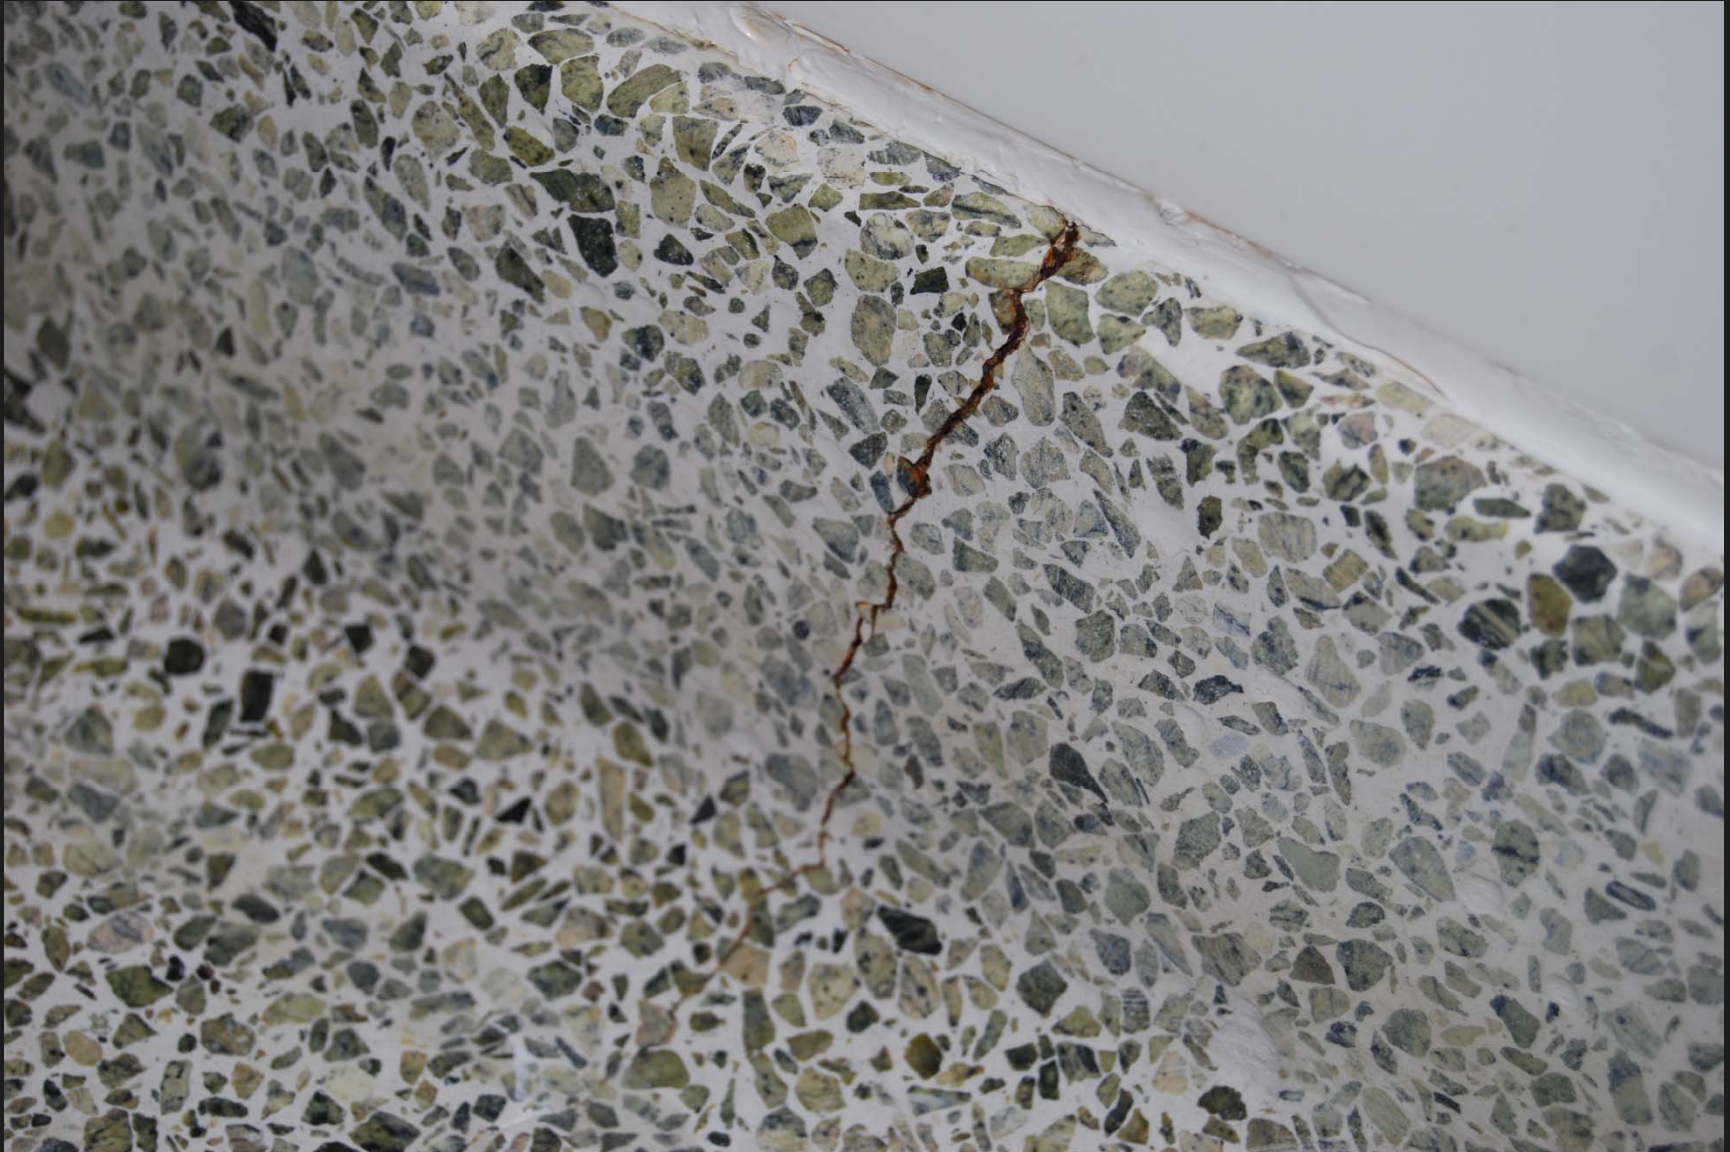
# Curb Crack Close-up

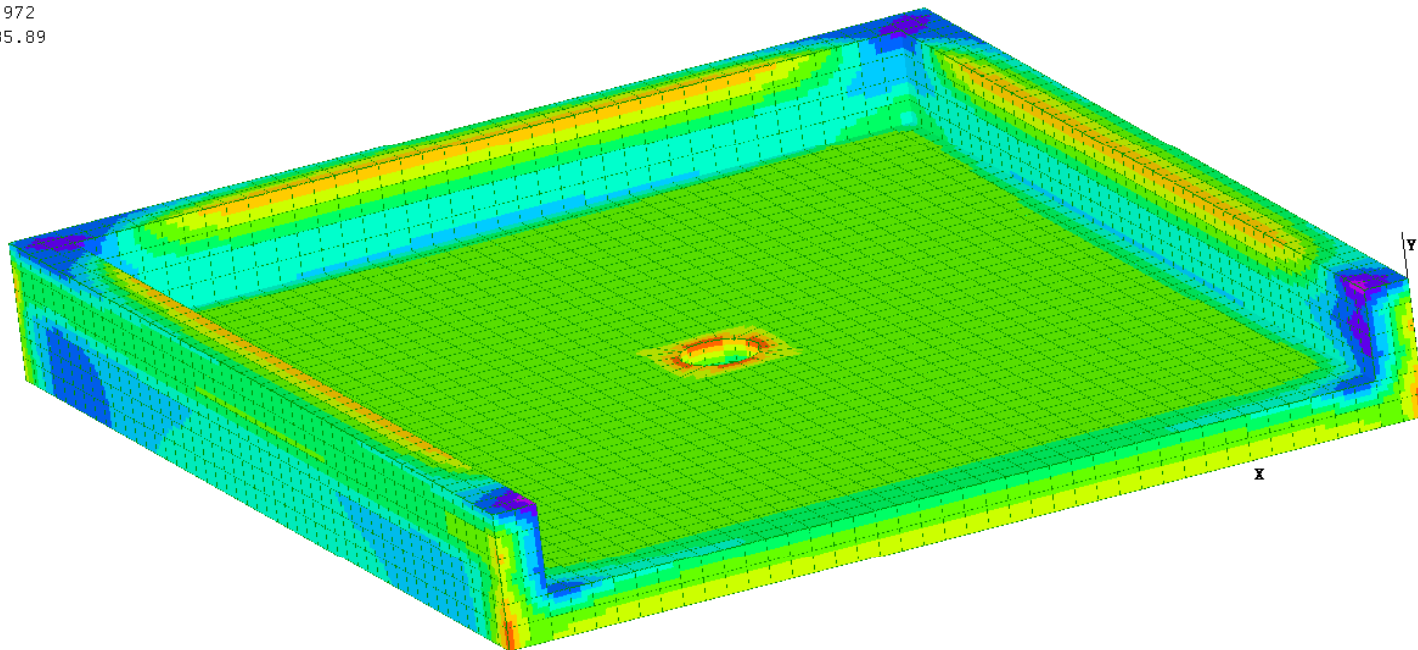
# Non Uniform Drying Shrinkage

Principal Stress 1

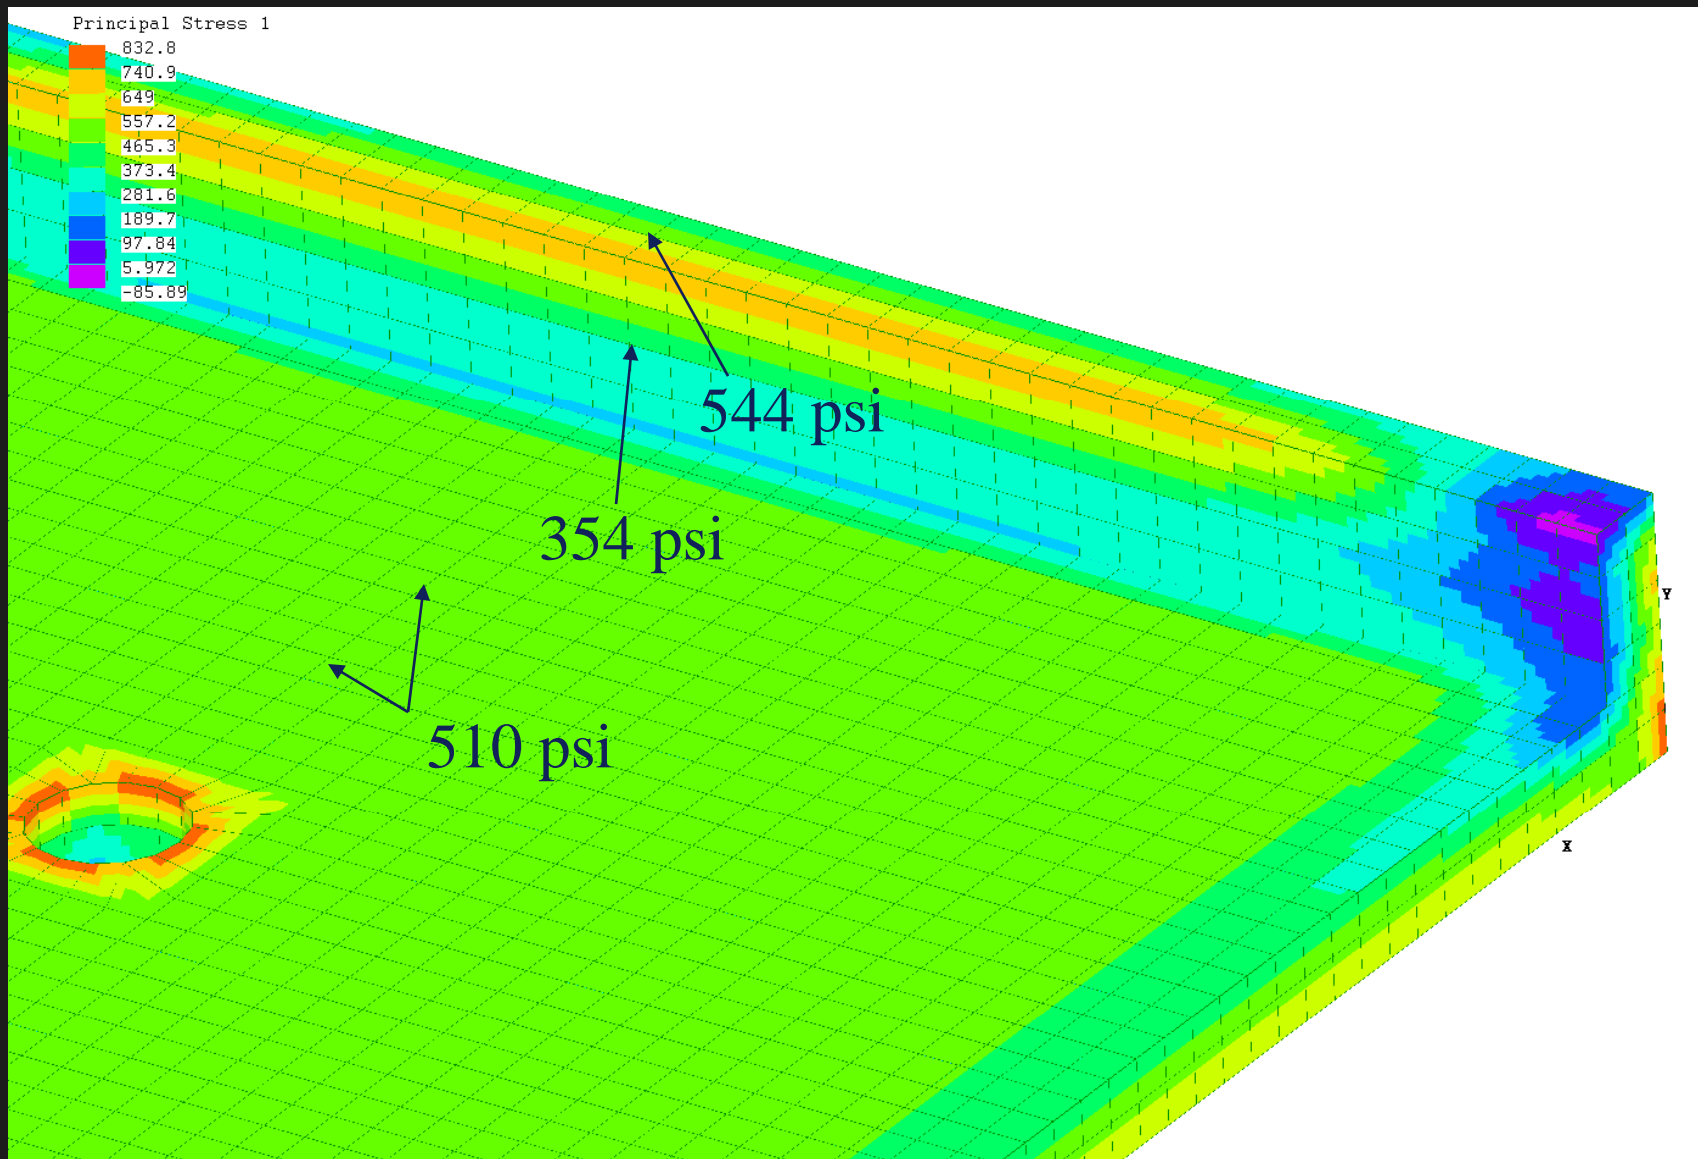
# Non Uniform Drying Shrinkage

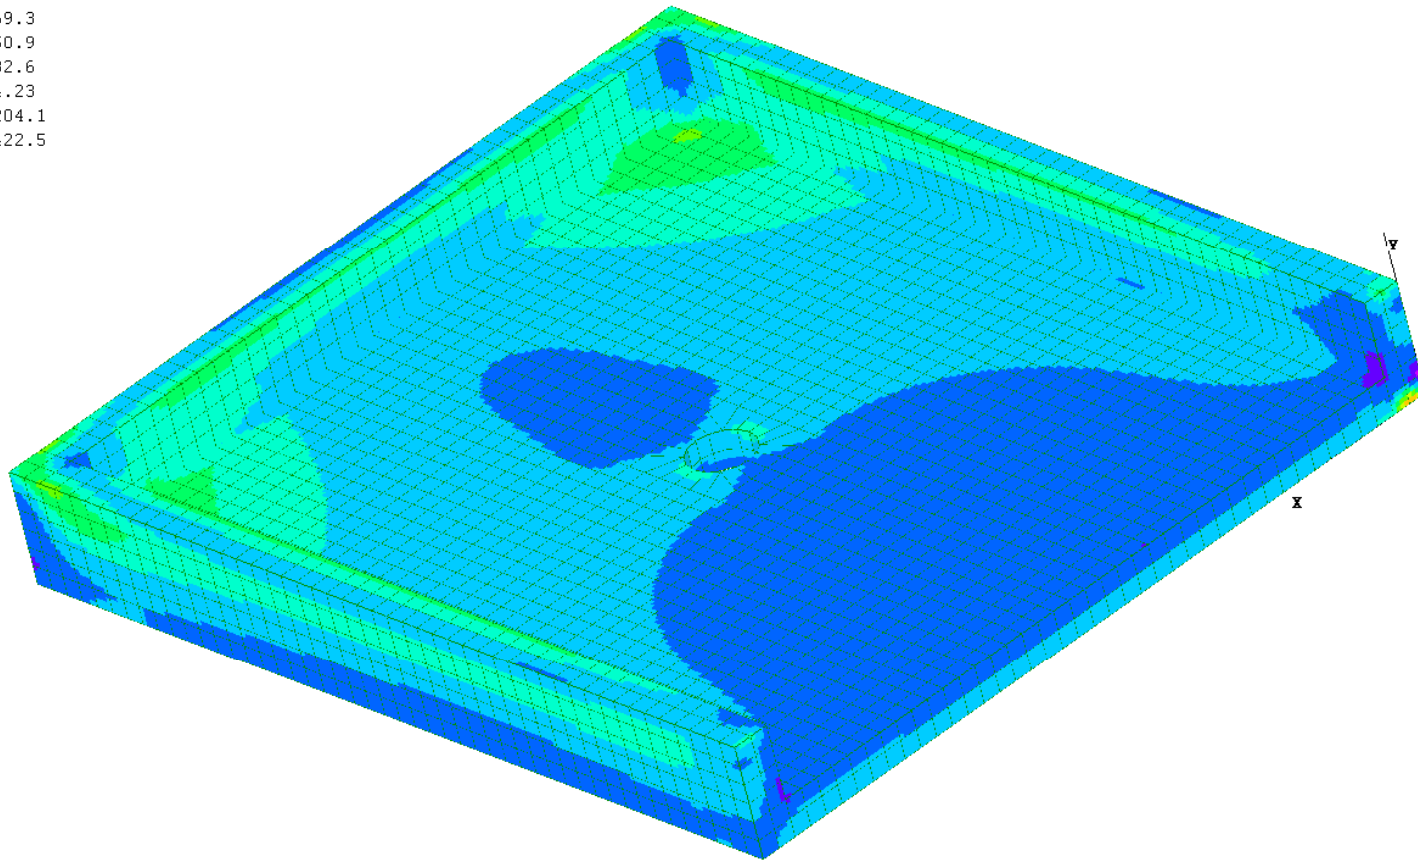
# Vertical Restraint Along Curb

Principal Stress 1

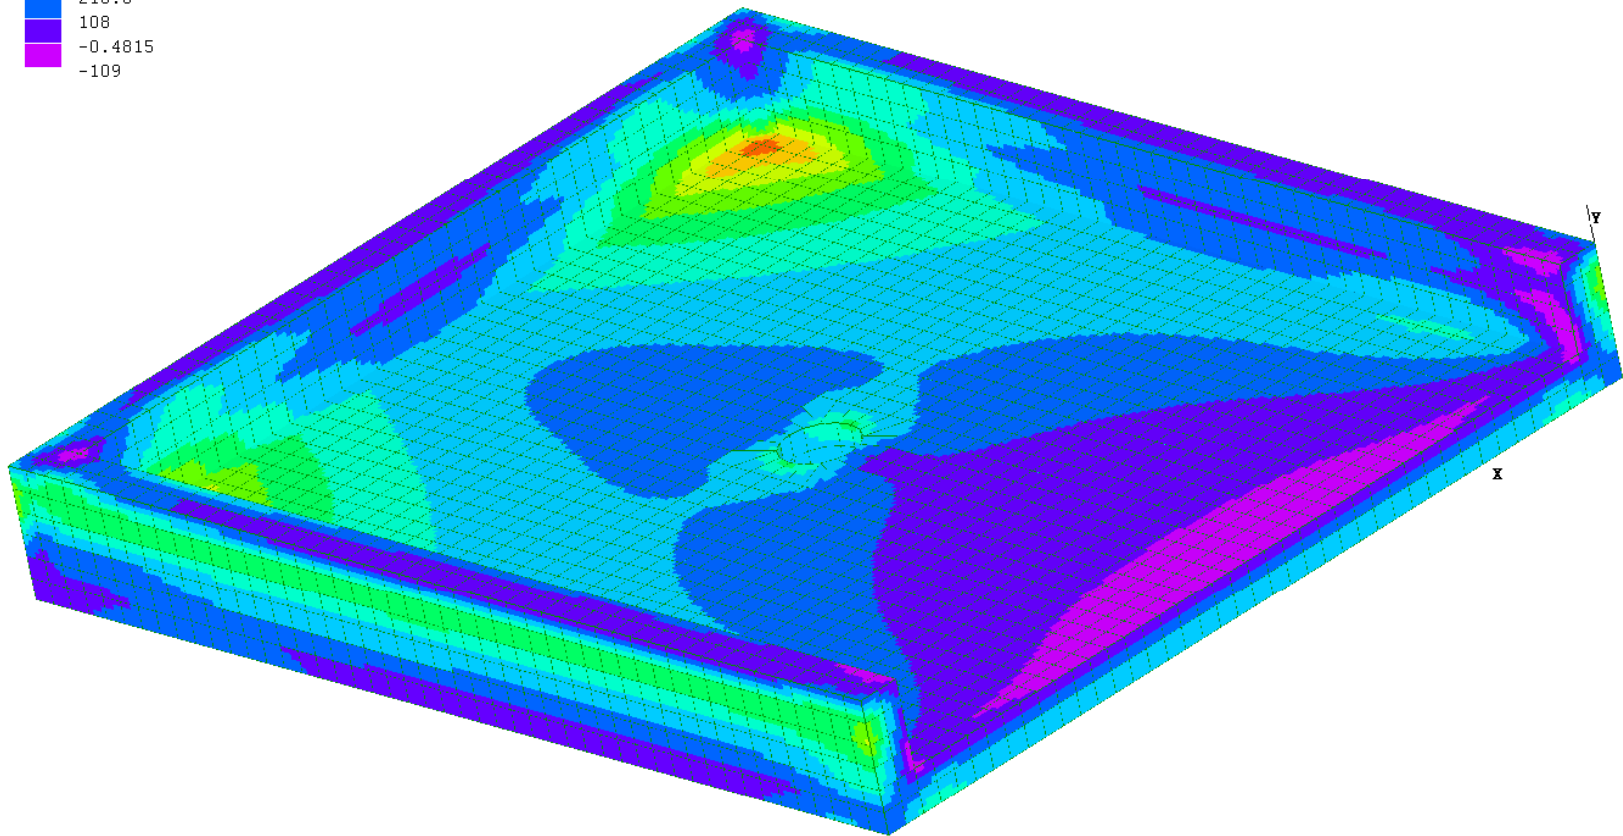
# No Vertical Restraint

Principal Stress 1

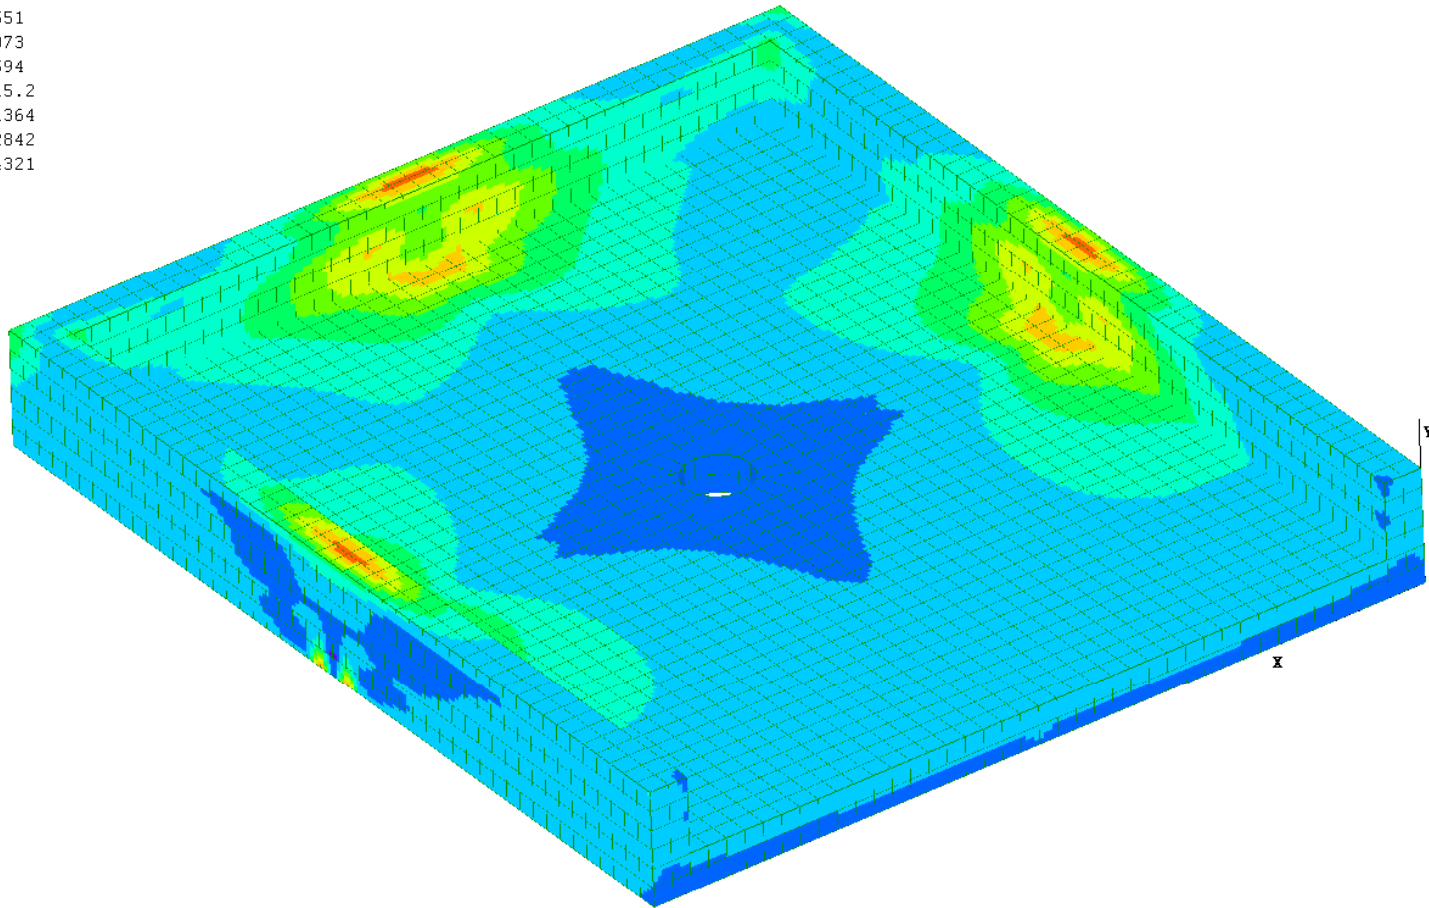
- **Bending stress**
- **Upward floor heave**
- **Upward vertical displacement**
  - **2 line deflections crossing at drain**
- **Curb edge restrained**

# Upward Heave of Floor .04 Inches

Principal Stress 1
